LE Erosion

Examples, Severity & Repair

DTU Wind Risø – 2018/02/22

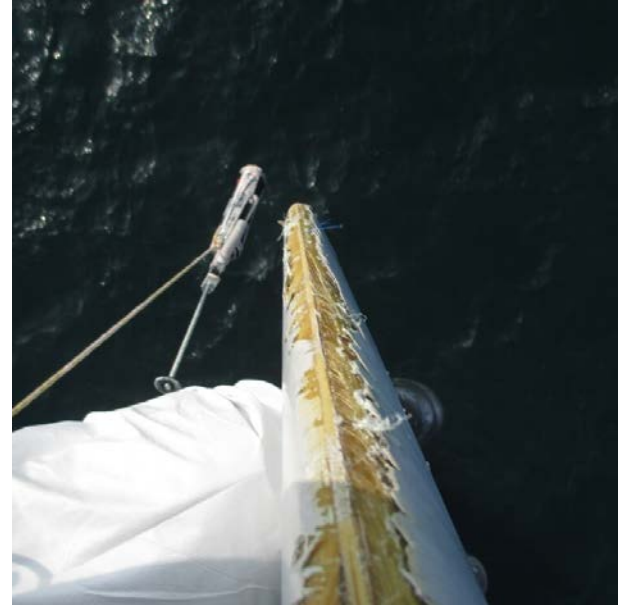
- Degradation of LE material
- Level of erosion depends on,
 - Climate conditions
 - Blade coating & underlying material
 - LE Protection, etc.
- Results;
 - May lead to high downtime
 - May require expensive repairs
 - Can result in loss of AEP

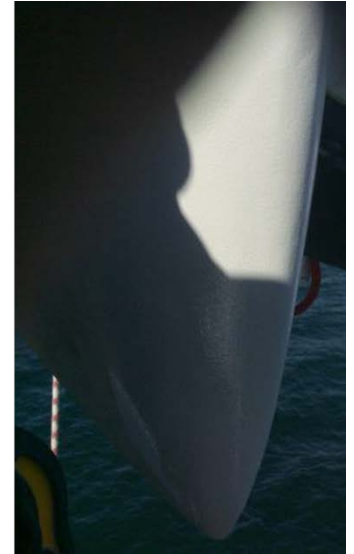
Repair

- Complexity depends on
 - Damage size
 - Depth
 - Blade type
- Also, weather conditions (!)
 - Effective on availability
 - May lead to increased costs
 - Temp. $>15^{\circ}\text{C}$ and $\text{RH}<70\%$
- New repair materials (?)
